Date 8/27/2009
City of Tanana
Landfill Insp.
& Upgrades

AUGUST 24, 2009 SITE INSPECTION REPORT WITH SITE SKETCH AND PHOTOS

CLASS III ANNUAL LANDFILL FIELD INSPECTION
FORMDate of
inspection 8/24/09NAME OF LANDFILL
PERMIT NUMBER:CITY OF TANANA
SW3A063-12file no. 780.15.001
facility ID _____LOCATION,
LANDOWNERCITY OF TANANA

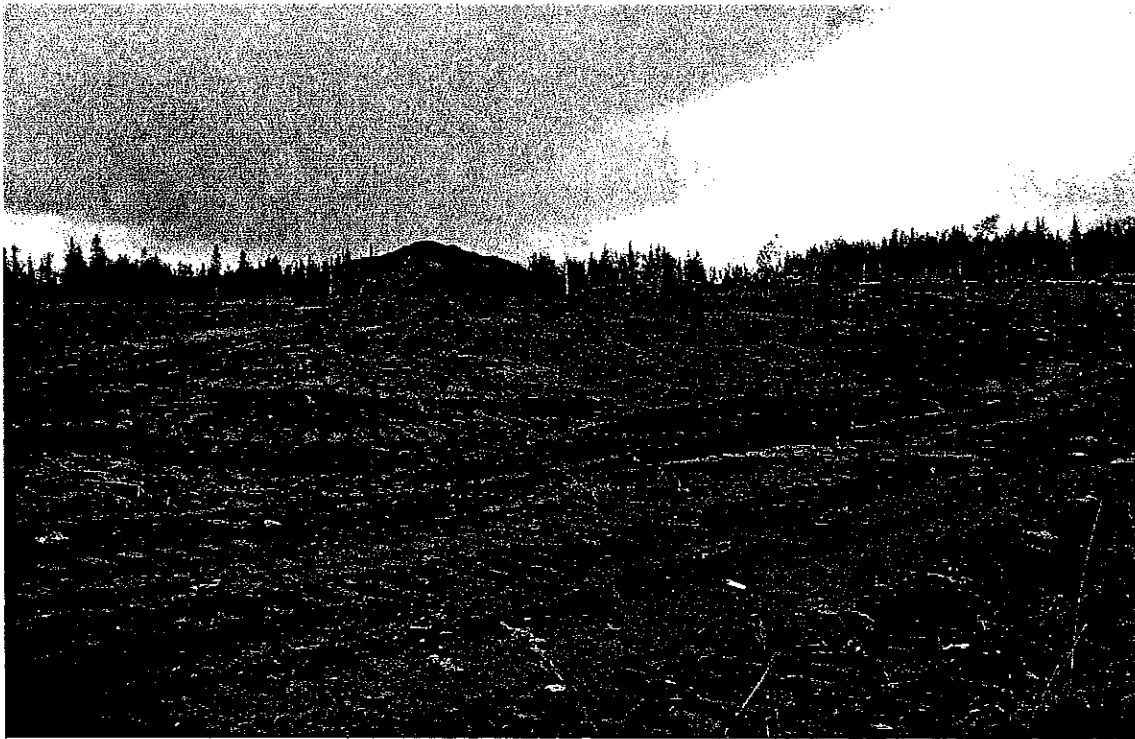
Photo 1: Looking south at the newly filled and graded section of the landfill. The area was cleared of debris, old cells were properly capped with soil and clean soil stockpiles spread. The large stockpile of soil in background is from excavated cell for upcoming hospital demolition project.

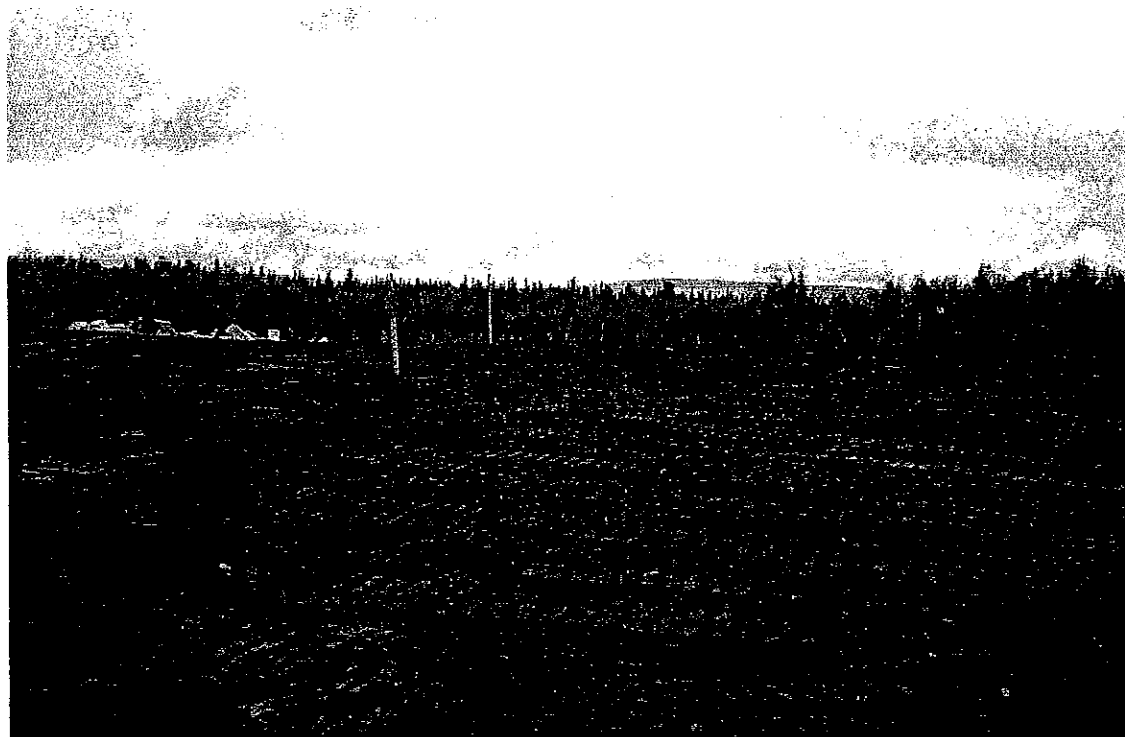
Photo 2: Looking north at filled in and graded section of the landfill. Posts shown on left center mark limits of cell recently filled and capped. Old refrigerators are shown to the left. They are waiting for Freon removal, then recycling.

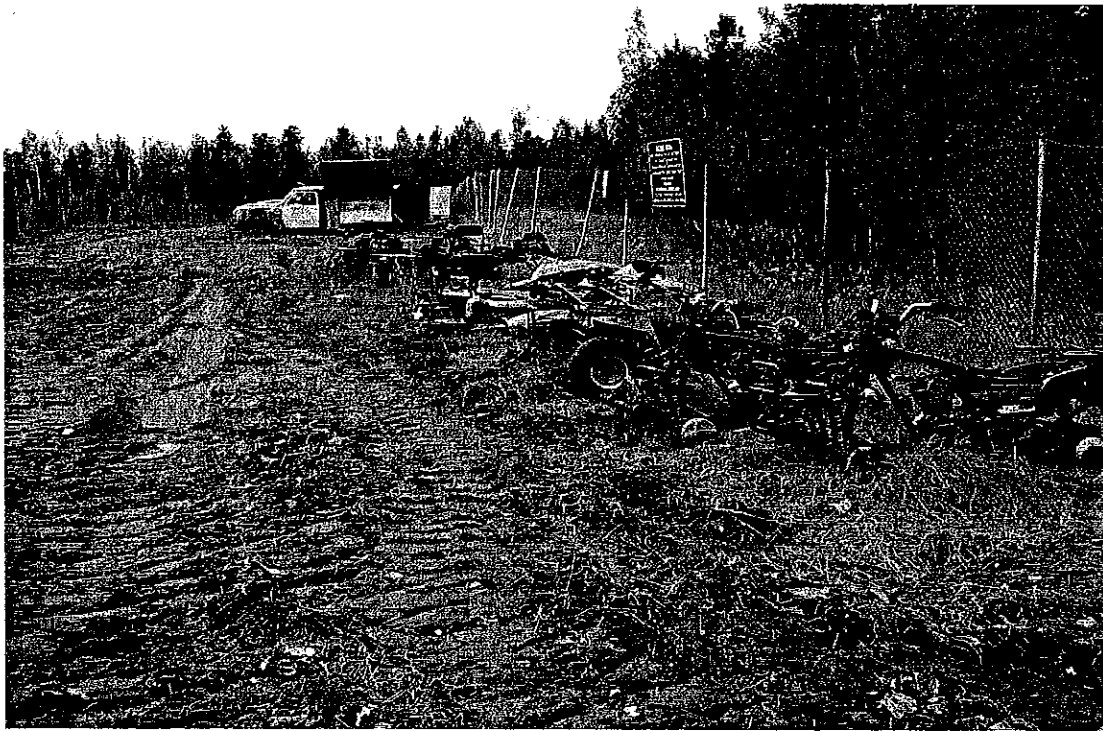
Photo 3: Looking north along east side of landfill. The area was cleared of recyclables, i.e. metal and old cars, buried in a new cell and capped. Recycling the debris was not optional until the following year and the space was needed.

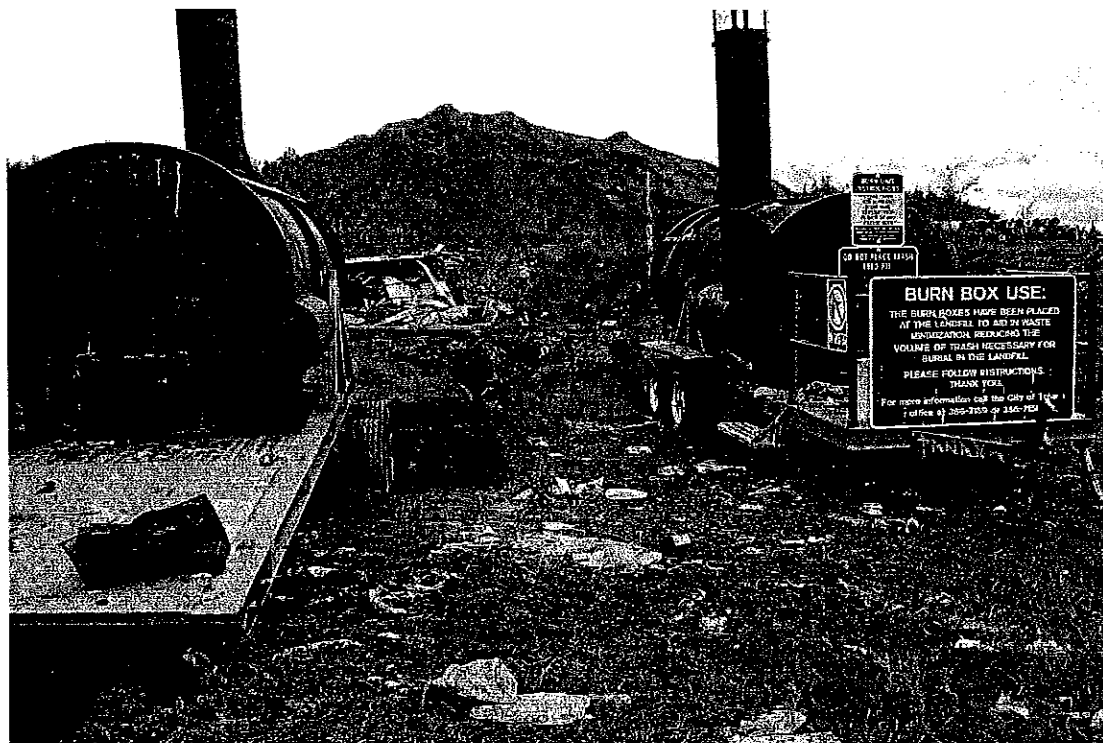
Photo 4: Looking west at the existing cell and burn boxes. Vandalism to the burn boxes has been an issue, with someone burning the tires to the units. The stockpile behind the cell is the newly excavated soil from the new hospital demolition cell. Burning debris is no longer an option as per ADEC. All debris must be buried.

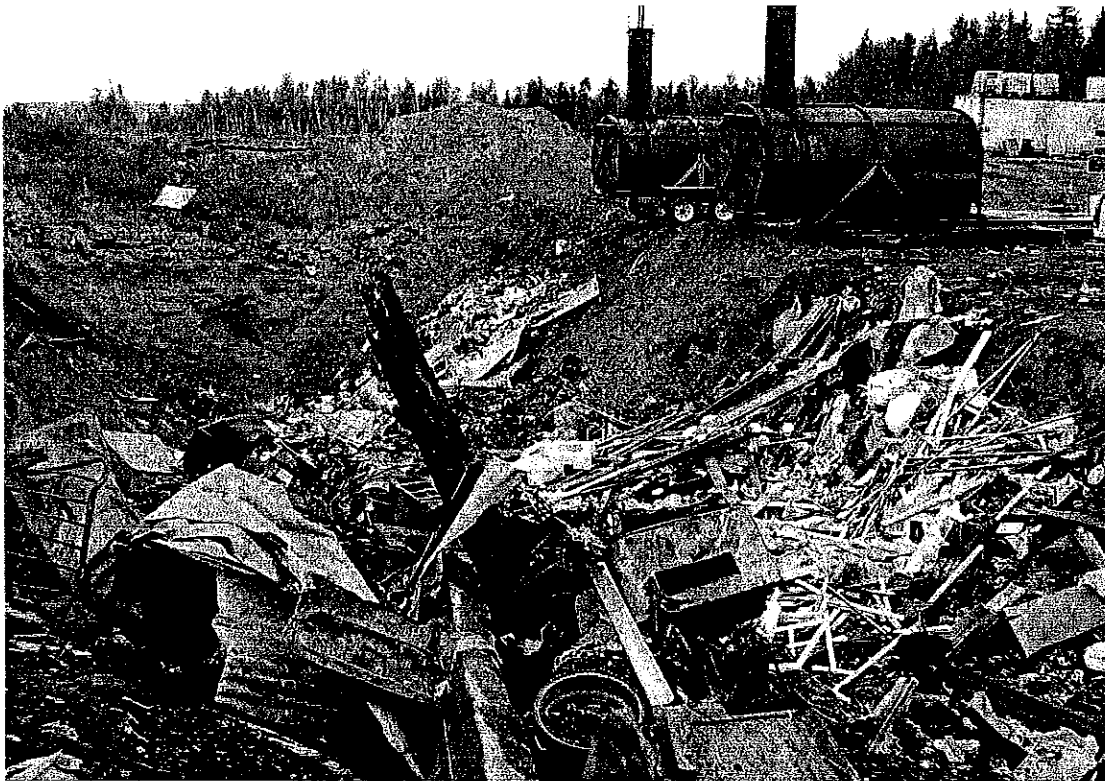
Photo 5: Looking north at the active cell. Residents' not using the burn boxes remains an area that needs attention. The connexes holding recyclables used oil and batteries have been moved to the east side as shown.

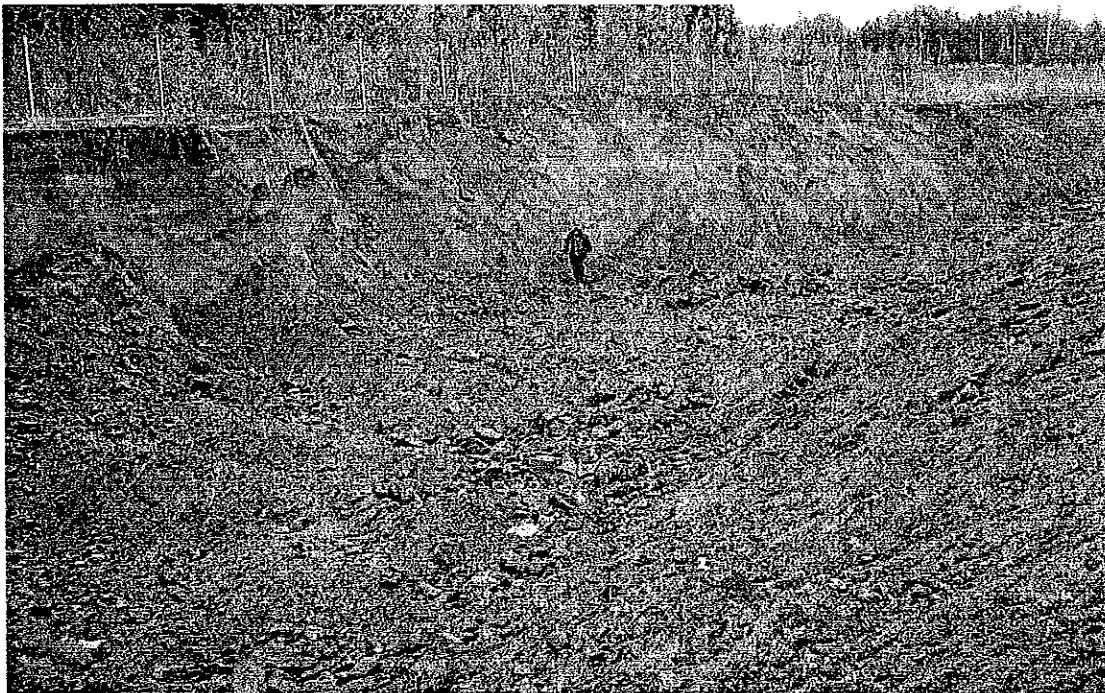
Photo 6: Looking west along the newly excavated cell for the hospital demolition debris expected to be up to 2500 cubic yards. The cell is approximately 240 feet long by 60 feet wide (at the top) by approximately 16 feet deep. Trucks will dump debris at the top of a ramp (not shown) and the City will doze the debris in.
